**DIVISION OF CONSTRUCTION
TRANSPORTATION LABORATORY
RESEARCH REPORT**

**EVALUATION OF STEEP CUT
SLOPES IN POORLY
CONSOLIDATED SEDIMENTS**

CA-11-2132-77-31

NOV. 1977

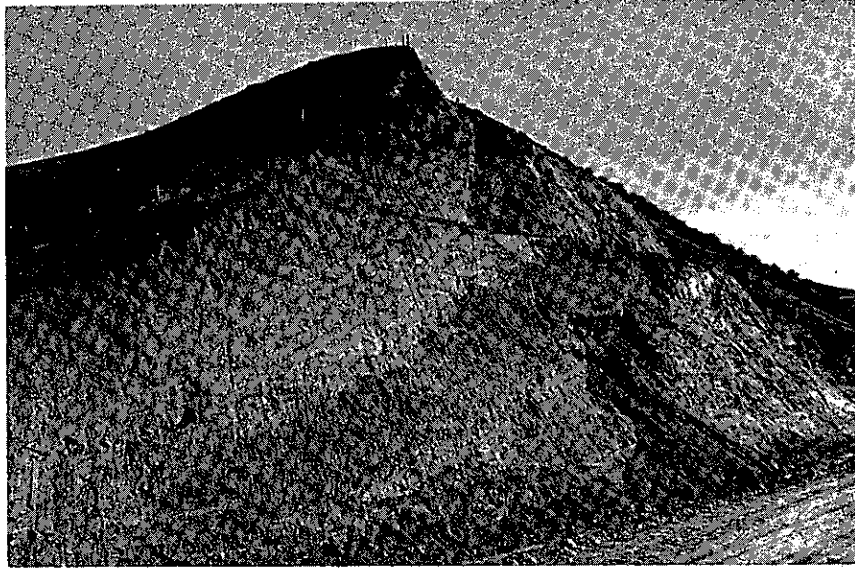
Photo 4

This 120 ft. high sidehill cut was constructed on a 3/4:1 slope with two 15 ft. wide benches above grade at 40 ft. intervals (Photos 4 through 9). Buff colored interbedded siltstone and sandstone on either end of the cut stand well on the 3/4:1 slope. A broad band of blue-gray claystone strikes diagonally across the middle of the cut face. Failures in this material began during construction (see Photos 4 and 5) and have continued to occur throughout the 5 year study period. A talus slope can be observed on the 6 ft. wide bench at grade (Photo 7).

Sta. 7+50 to 11+00. Photo taken shortly after construction. Note beginning of failure in blue claystone unit.

The constructed benches were lost and the 3/4:1 slopes failed. As a result of observations made during this study, a 1 1/2:1 cut slope with a 20 foot wide debris bench at grade would be recommended for this area.

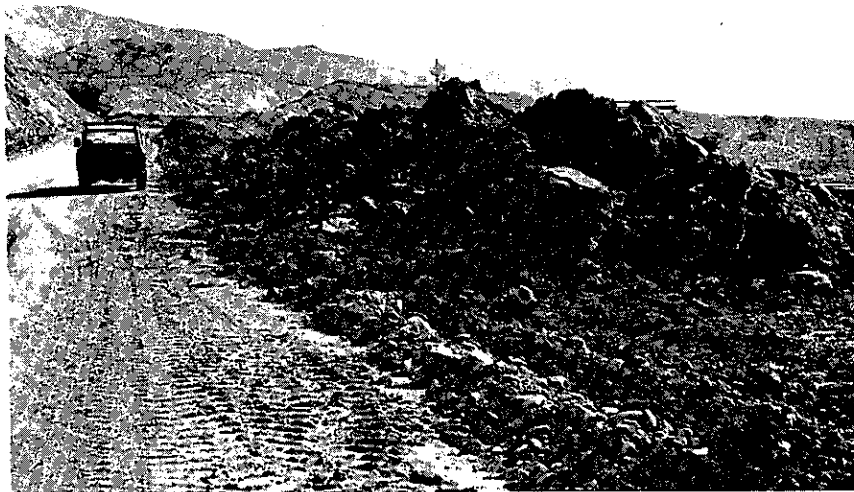
Photo 5

Sta. 7+50 to 11+00. Failure closed roadway 7 days after Photo #4 was taken. Note slide debris pushed to side to reopen roadway.

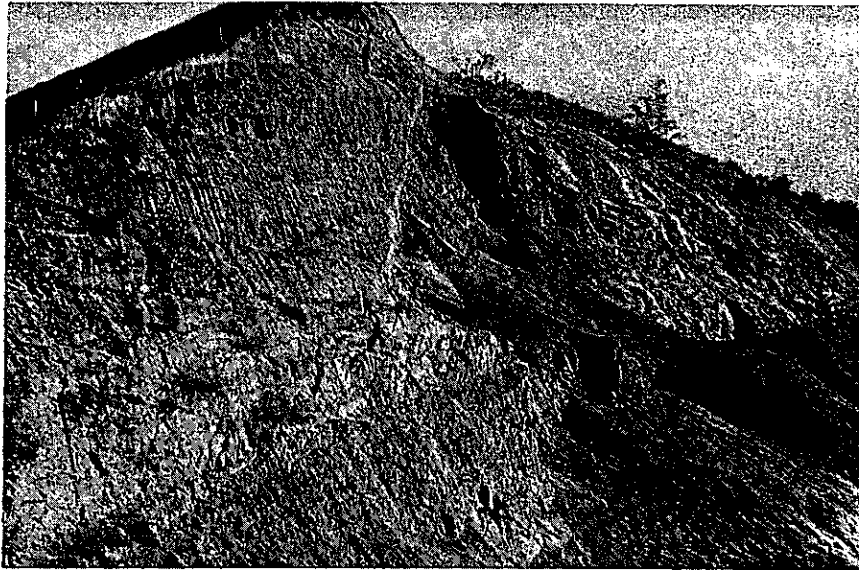
Photo 6

The centers of both benches above grade have been breached by sliding (Photo 9). In time these benches will be destroyed by mass wasting. Photos 6 and 8 show cracking well developed which will lead to further small slides in years to come. The fence located at the edge of the top of cut will have to be moved in the future because of breakage along the edge.

Sta. 7+50 to 11+00. Photo taken midway through project. Note cracking on first bench and near man standing on second bench.
10/16/74

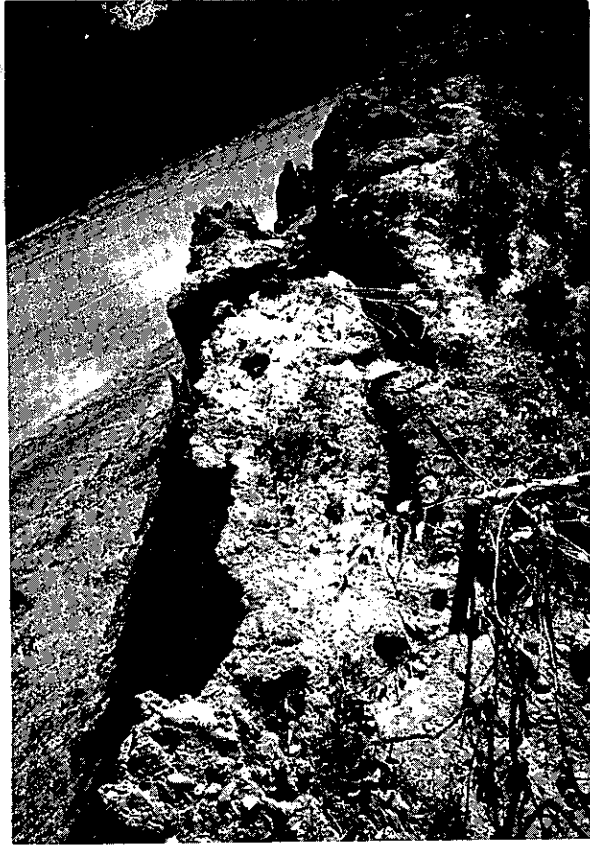
Photo 8

Sta. 7+50 to 11+00. View of
cracking from first bench.

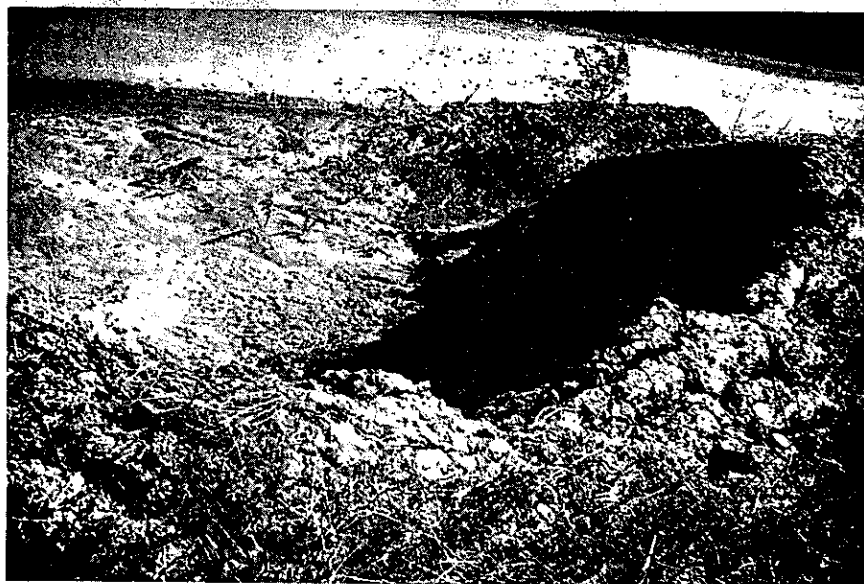
Photo 9

Sta. 7+50 to 11+00. Failure of
second bench above roadway.
4/7/77

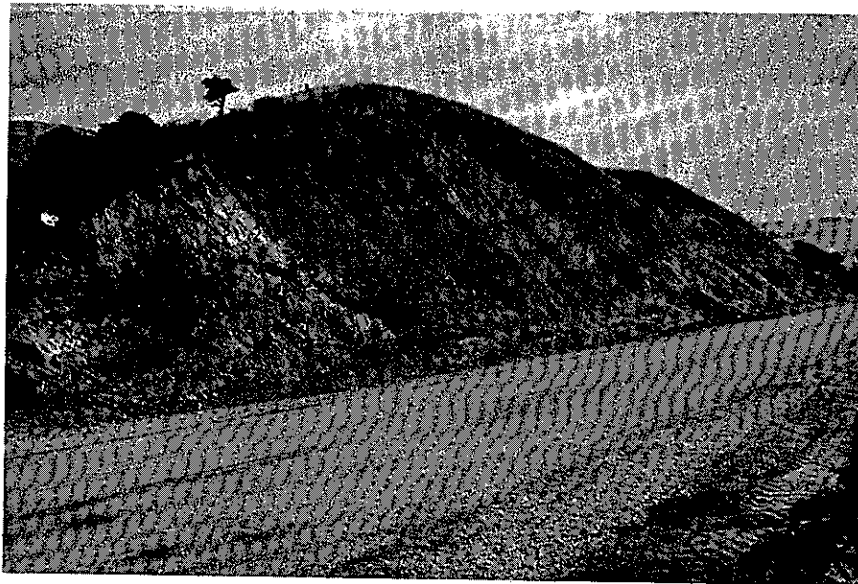
Photo 10

Sta. 15+00 to 17+00 Lt. Generally stable cut slope, but extensive sloughing of less resistant units is occurring.
10/16/74

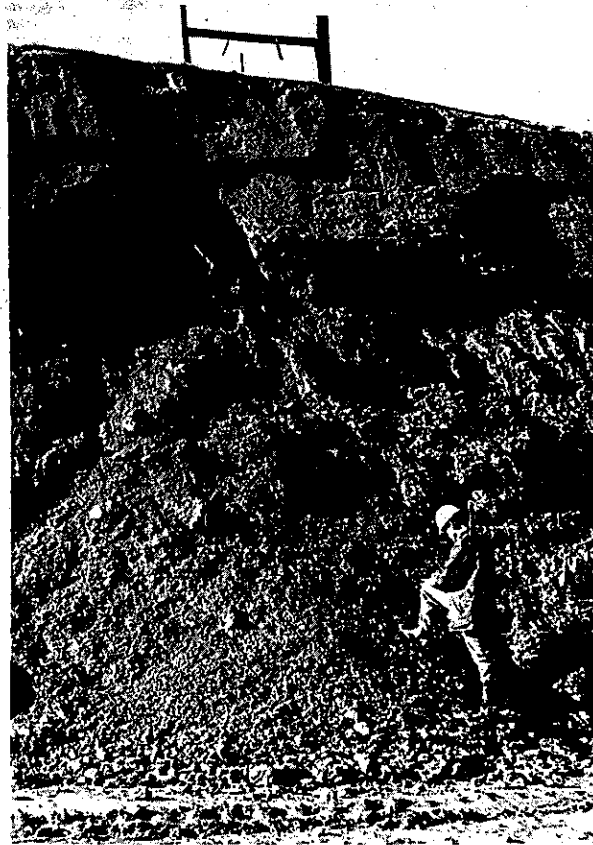
Photo 12

Sta 18+00 to 23+00 Rt. Cut slope failure
shortly after construction.
2/6/73

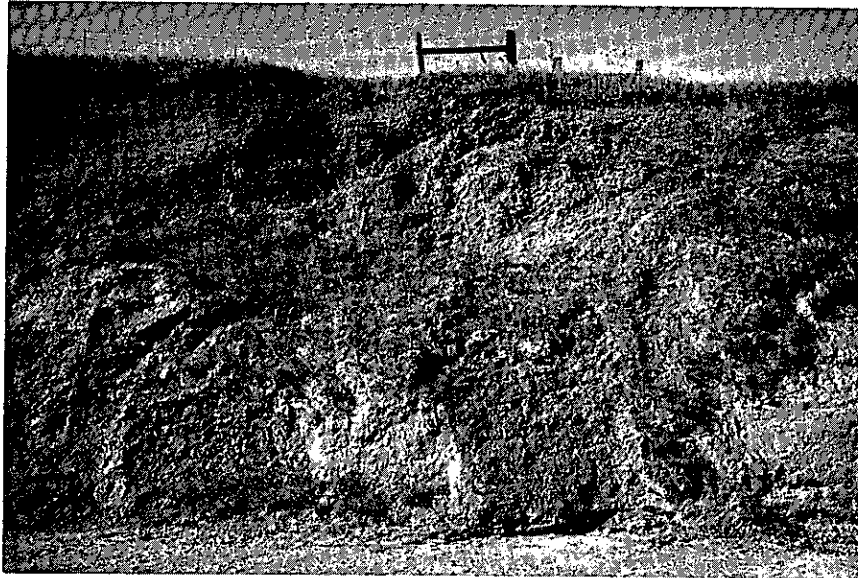
Photo 13

Sta. 18+00 to 23+00 Rt. Same view as
Photo 12 as it looked 4 years later.
4/7/77

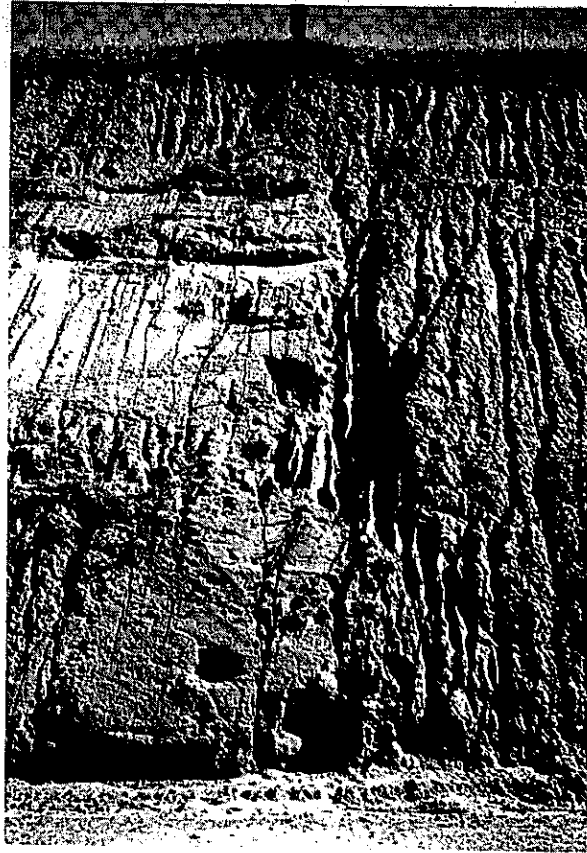
Photo 14

Sta. 18+00 to 23+00 Lt. Erosional
fluting in sandy siltstone.
4/7/77

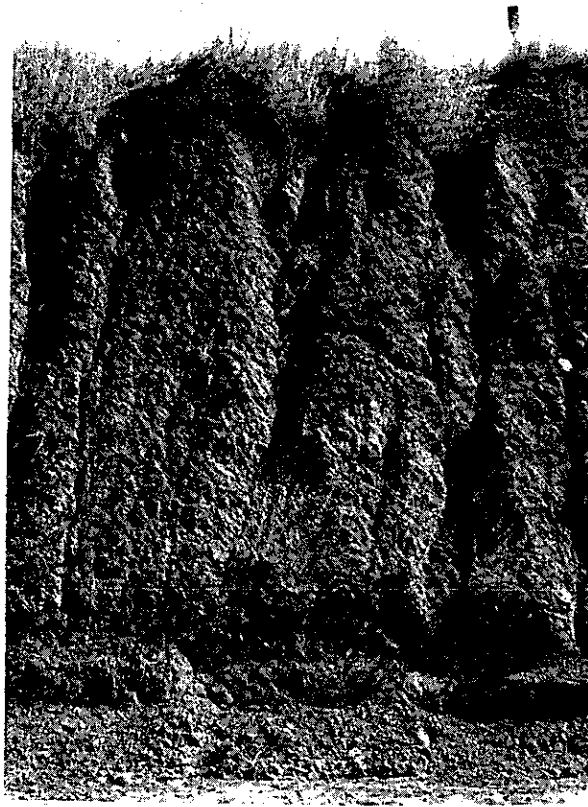
Photo 15

Sta 18+00 to 23+00 Lt. Gullying
in clayey siltstone.
8/28/75

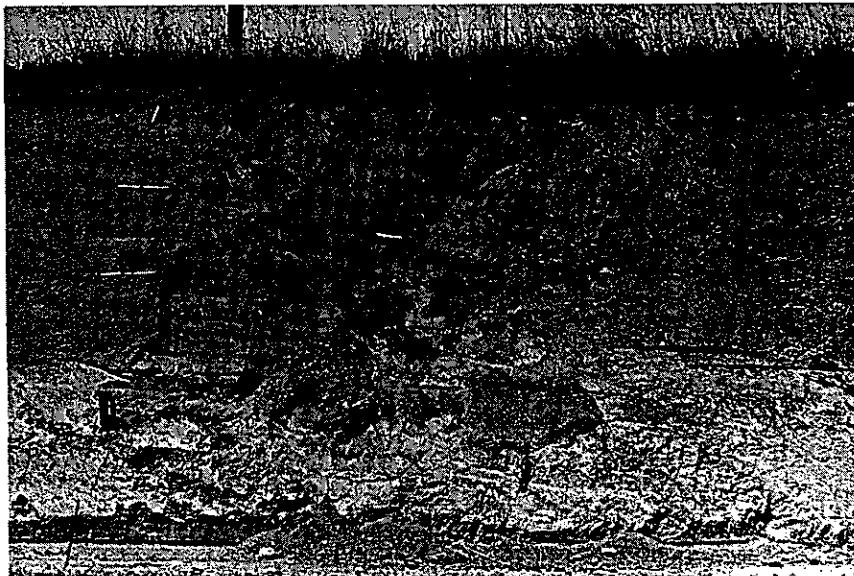
Photo 16

Sta. 25+50 Rt. Slide scarp after debris has been removed.

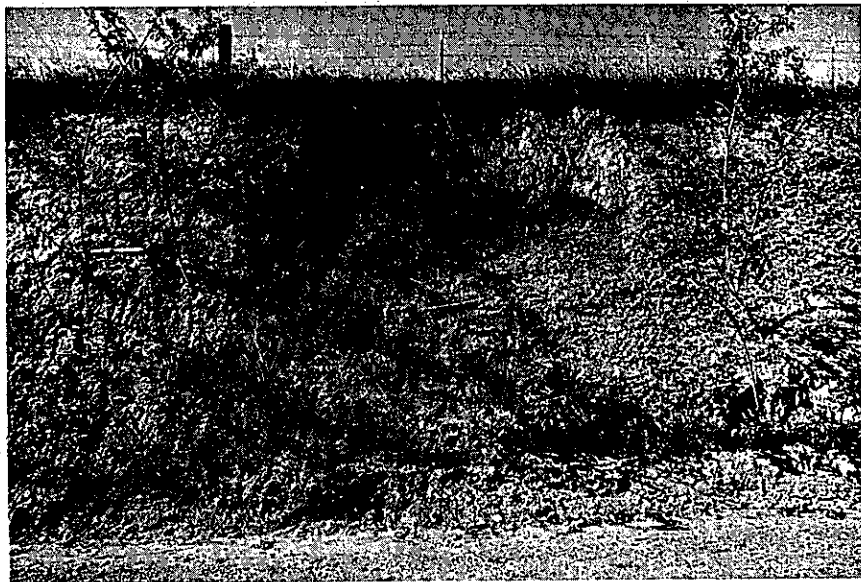
Photo 17

Sta. 25+50 Rt. Same slope as Photo 16 as it looked 4 years later.

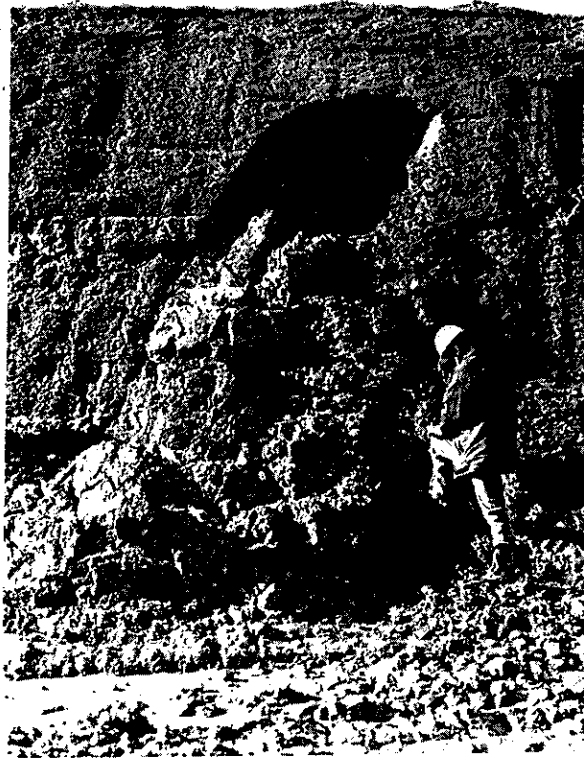
Photo 18

Sta. 27+00 Rt. Small popout.
2/6/73

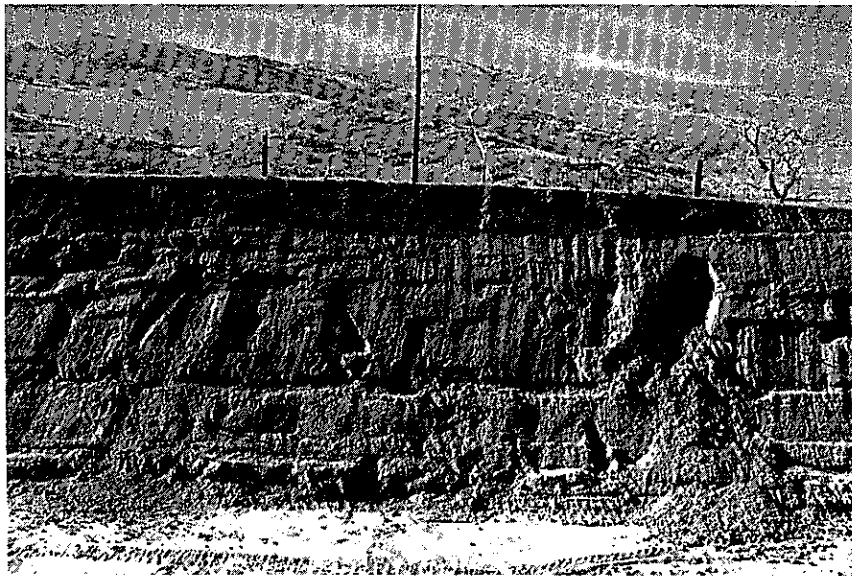
Photo 20

Sta. 28+00 Rt. Small popout and beginning of two more. Note absence of gullys on north facing slope.

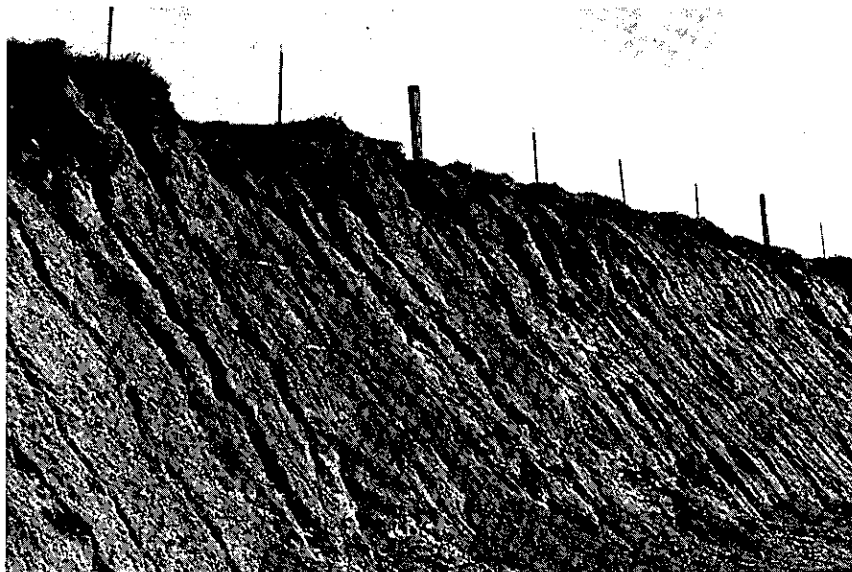
Photo 21

Sta. 28+00 Lt. Development of gullying on south facing slope. Similar material (clayey siltstone) as Photo 20.

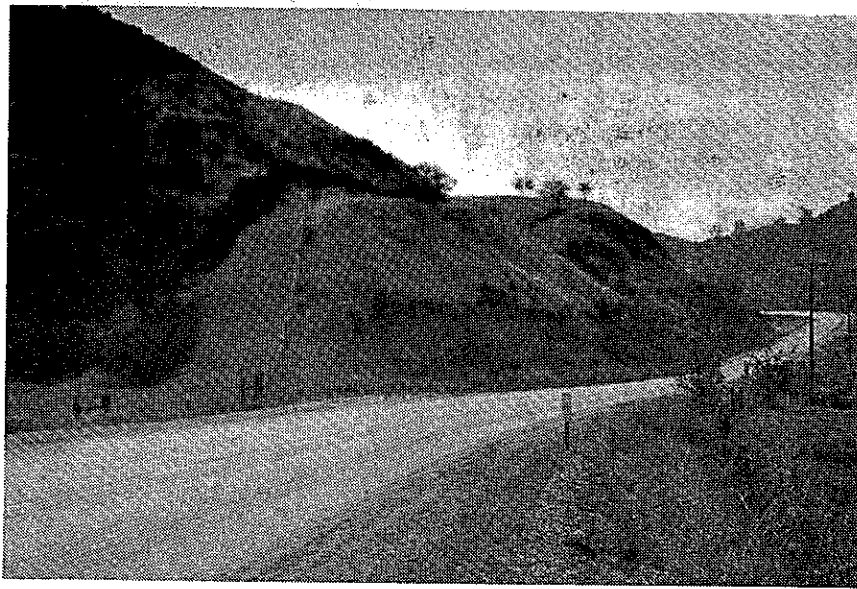
Photo 22

Sta. 44+00 to 47+00. Minor 3/4:1 cut slope
showing some sliding and erosional effects.
4/7/77

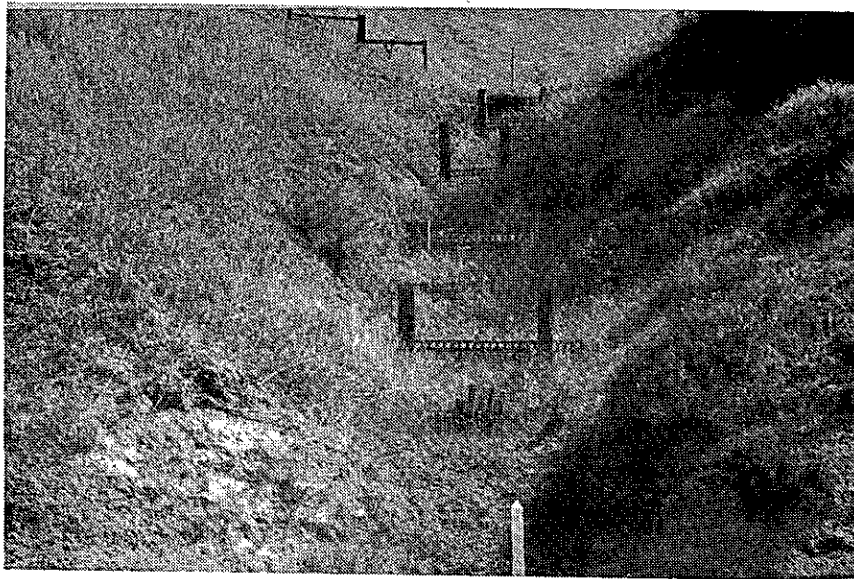
Photo 23

Sta. 47+75. Old aircraft landing mats used
in gully to curb erosion.
4/7/77

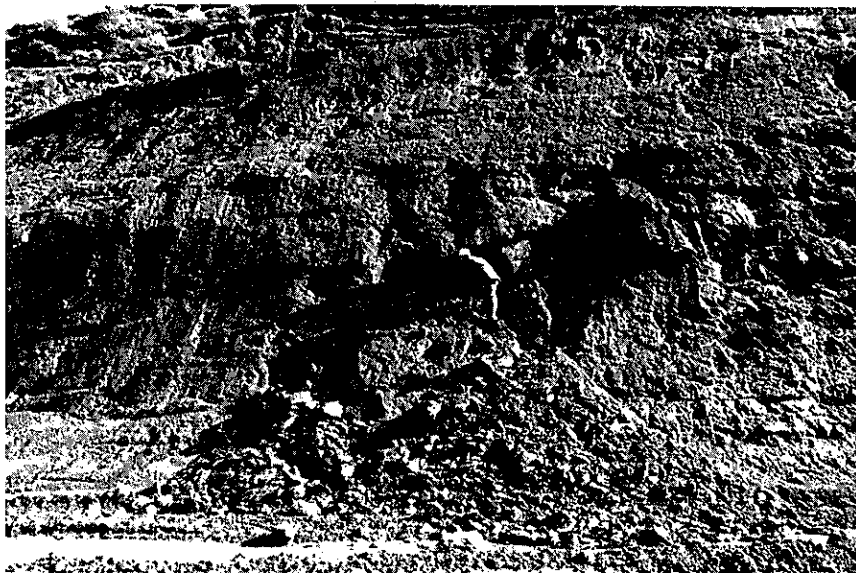
Photo 24

Shortly after construction a bedding plane failure was apparent near grade on this 62 ft. high benched cut (Photo 24). Ten days later (Photo 25) the failure had progressed to the bench 40 ft. above grade. Some slope loss was also noted at that time from the bench to the top of cut. Photo 26 shows the failed cut as it looked in April 1977. It appears that this slope will continue to fail until the bench has been totally removed and a 1 1/4 or 1 1/2:1 slope has been established.

Sta. 50+00 to 52+50 Lt. Beginning of bedding
plane failure.

Poorly consolidated and cemented sandstone and siltstone were underlain by soft, unconsolidated claystone. Loss of this incompetent material by mass wasting undermined the overlying sediments, which then failed. A 1 1/4:1 slope design would be recommended in this area based on the 5 year study.

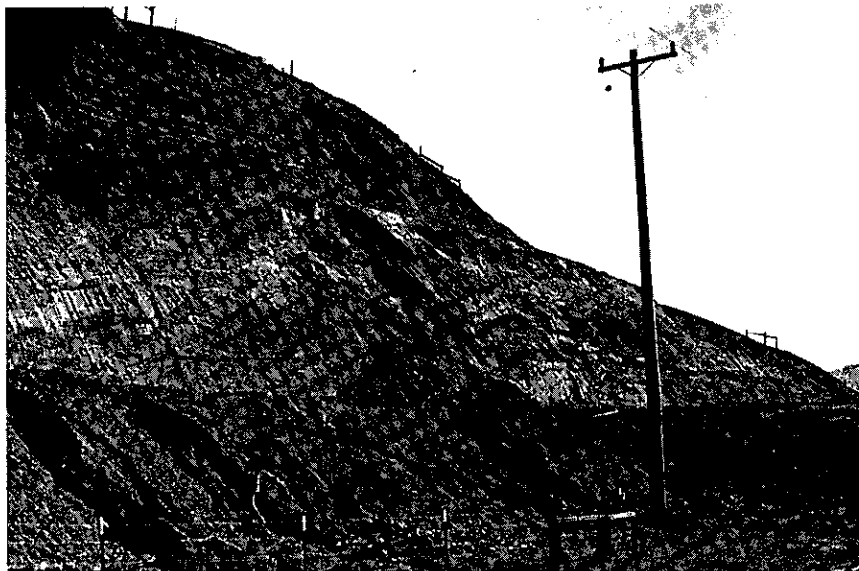
Photo 25

Sta. 50+00 to 52+50 Lt. Taken 10 days after
Photo 24. Note progressive failure upslope
and also above bench.

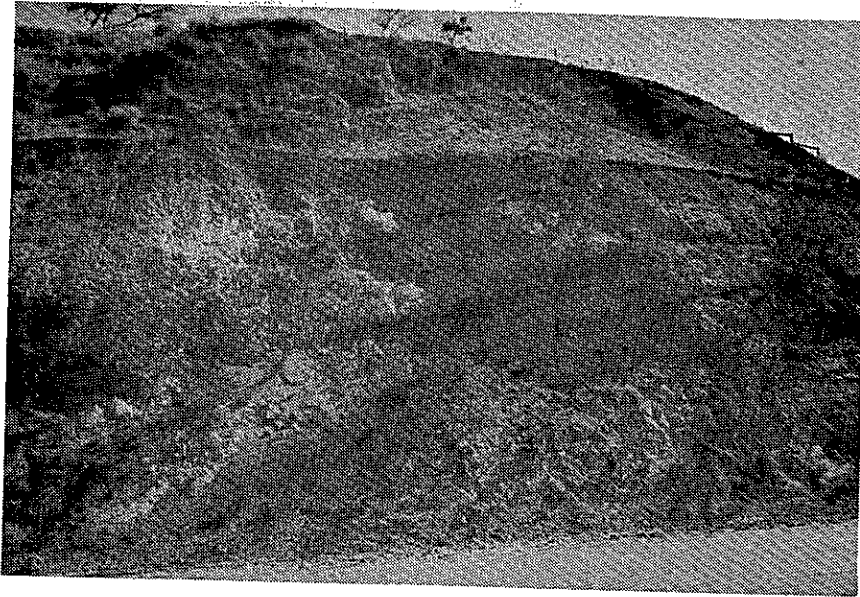
Photo 26

Sta. 50+00 to 52+50 Lt. Taken 4 years after
Photo 25. Note extensive failure above and
below the bench.

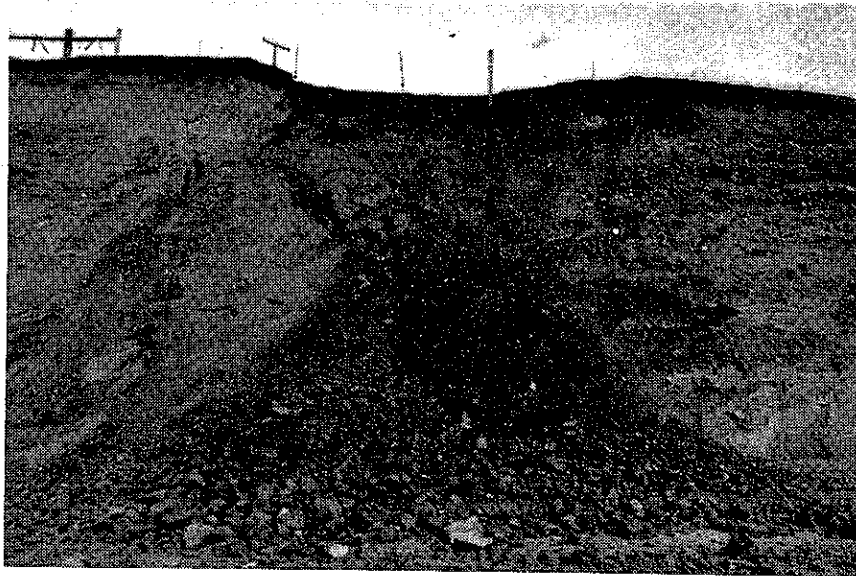
Photo 27

A pocket of unconsolidated gravel overlying buff punky sandstone failed on the 3/4:1 slope left of Sta. 65+75 during construction (Photos 27 and 28). Four fence posts were undermined and left suspended (Photos 27 and 44). Raveling of blue claystone (Photo 29), and sliding on an inclined clay seam are now occurring (Photo 30).

Sta. 65+75. Failure of pocket
of gravel near top of cut.
12/12/72

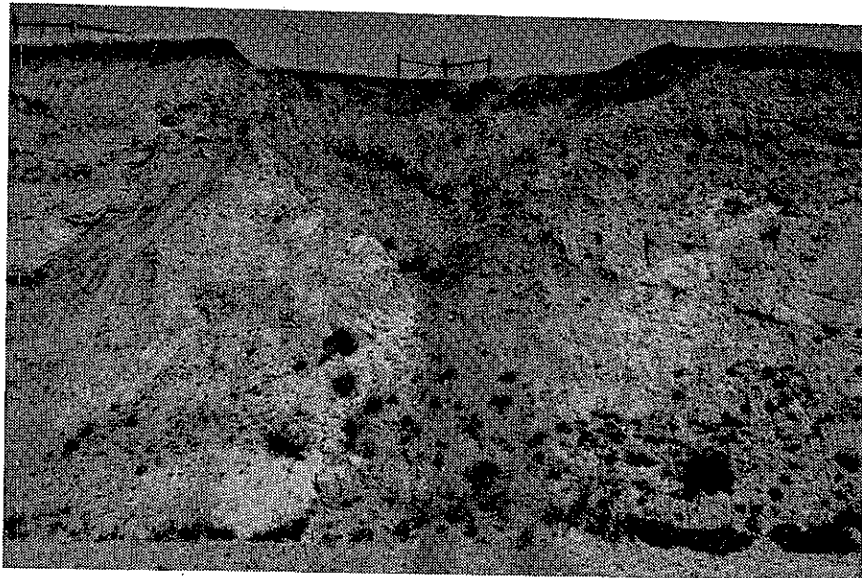
Photo 28

Sta. 65+75. As it looks in 1977.
4/7/77

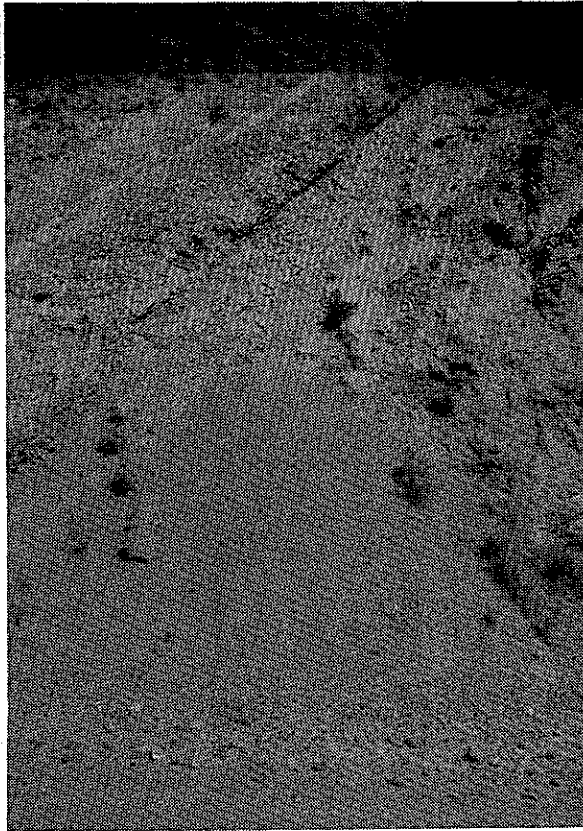
Photo 29

Sta. 66+50. Raveling of blue clay
stone member of San Benito Gravels.
4/7/77

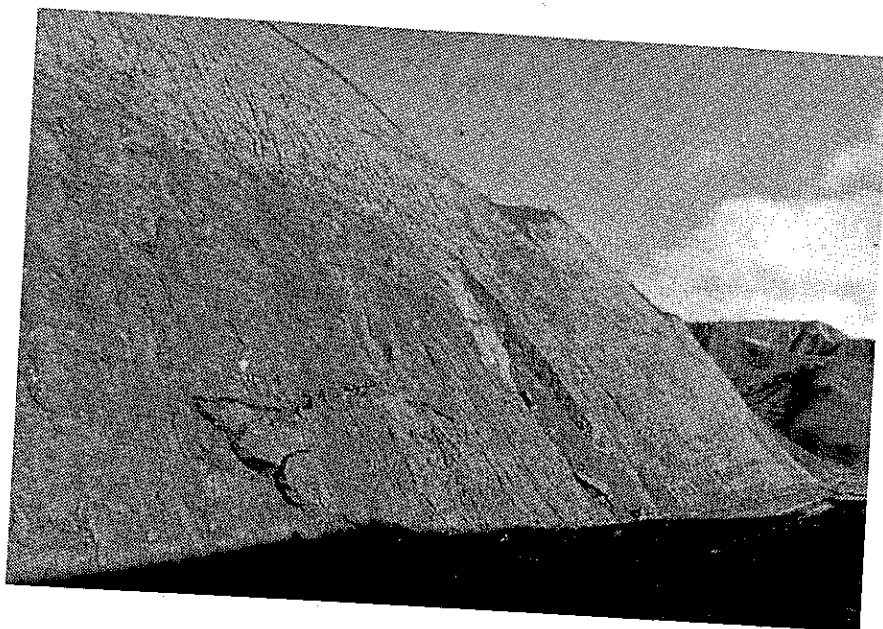
Photo 30

Sta. 67+00 to 70+00. These failures occurred
shortly after construction and are still active.
2/6/73

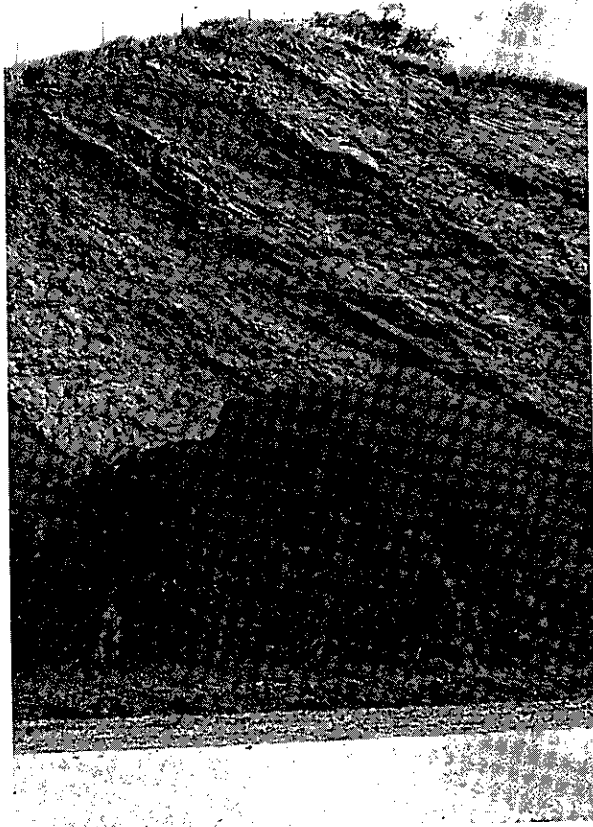
Photo 31

Sta. 91+00 to 94+00. Dipping Sedimentary
Units are basically stable but extensive
raveling has occurred.

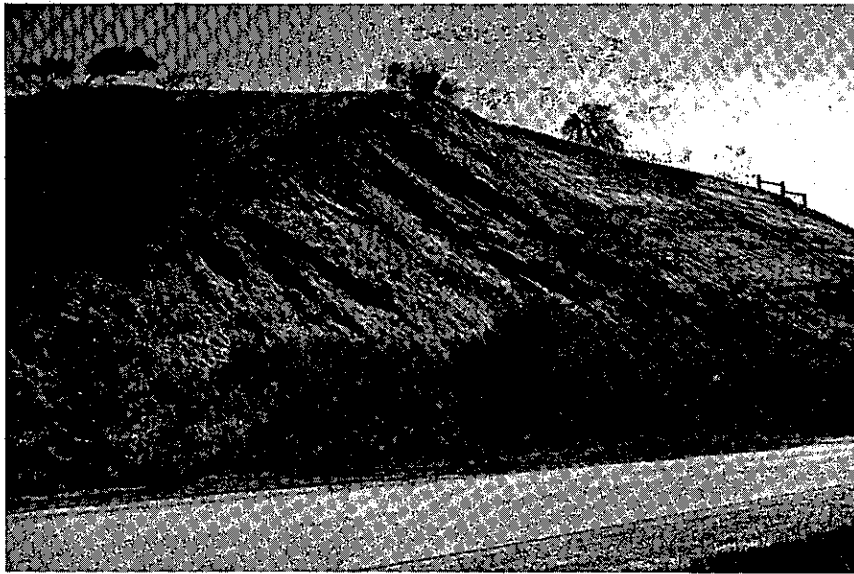
Photo 32

Sta. 91+00 to 94+00. Rate of Raveling has been reduced to the point that some vegetation is growing on the talus slope.

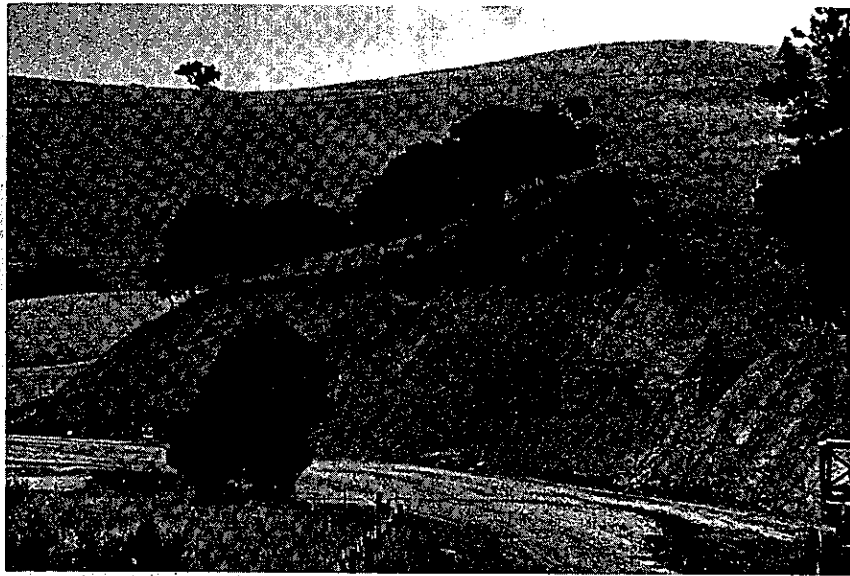
Photo 33

In June 1973 the slope failed completely and was reconstructed at a 1 1/2:1 ratio (Photos 33 and 34). This slope modification generated approximately 8,000 additional cubic yards of earthwork. The new slope performed well until February of 1975. At that time movement along a clay seam that dips into the roadway was noted (Photo 35). It is anticipated that this movement will continue and that the slope above the plane will eventually fail completely.

Sta. 142+00 to 147+00. Failure of initial
3/4:1 cut slope.

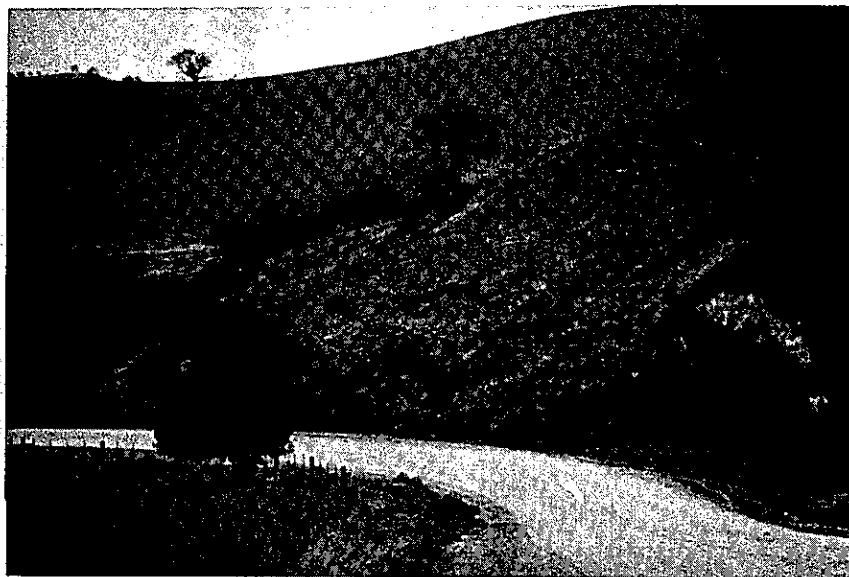
Photo 34

Sta. 142+00 to 147+00. Slope laid back to
1 1/2:1. Note failure in middle of cut.

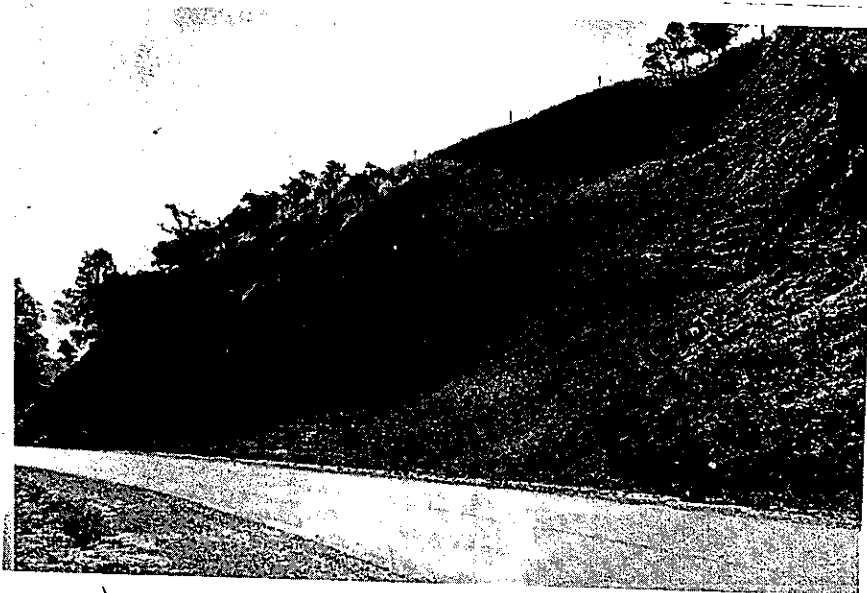
Photo 37

Sta. 188+00 to 192+00. Slope as it appeared
2 years later with the slide debris removed.
10/16/74

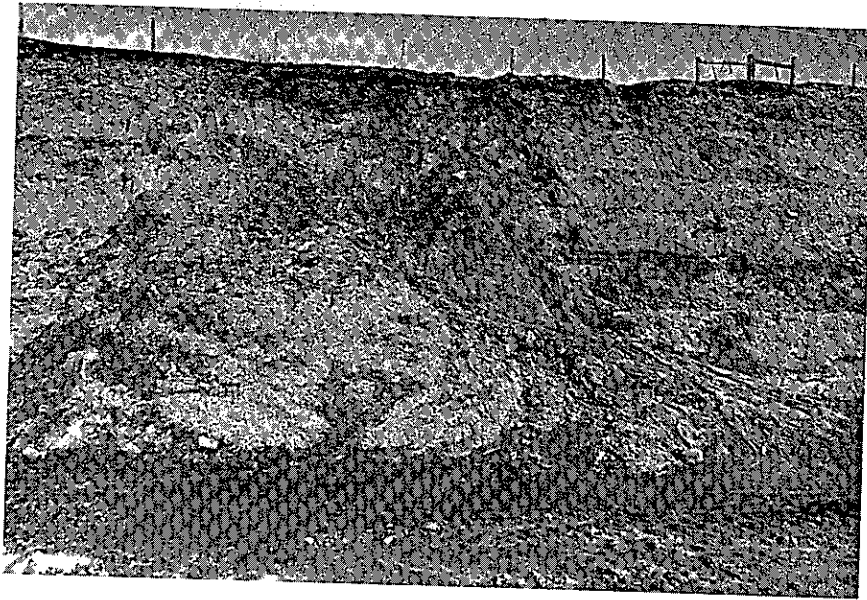
Photo 38

Stepped slopes were constructed on this 25 ft. high 1:1 slope. Approximately 50 yds. of gravelly terrace deposits slipped out near the top of cut, (Sta. 211) during construction (see Photo 38). Apart from this small failure, the cut slopes, both left and right, have performed well. Most of the steps have disappeared now leaving the former treads more heavily vegetated than the risers. (Photo 39). On the eastern end of the cut steps are more prominent in the slightly cemented gravels than in the sandy siltstone.

Sta. 211+00 Lt. Minor failure of gravelly
lens in stepped slope.
2/16/73

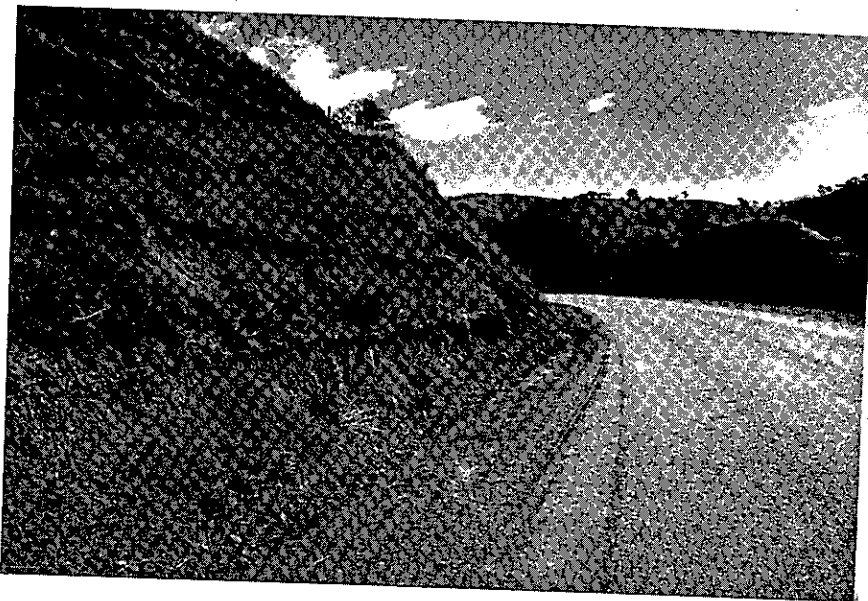
Photo 39

Sta. 208+00 to 213+00 Lt. Stepped cut slopes.
12/9/76

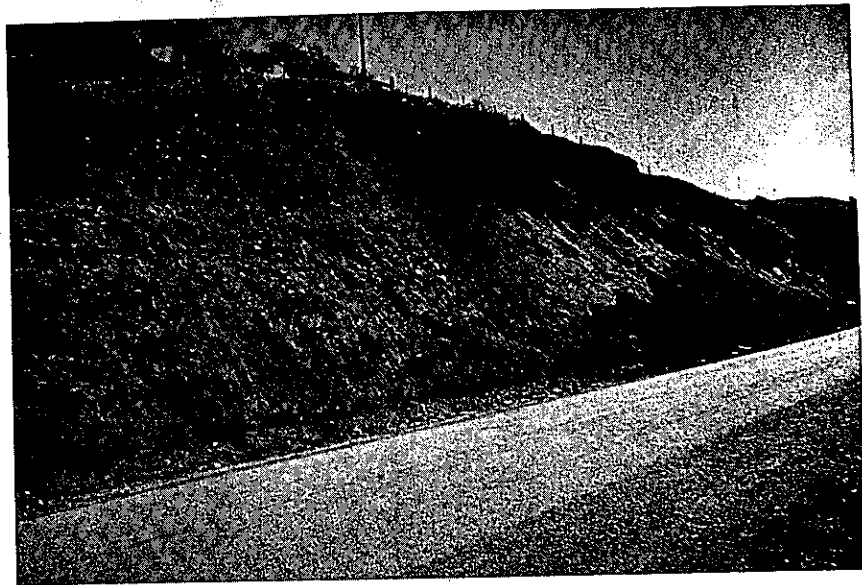
Photo 41

Three-quarter to one stepped cut slopes were constructed in sheared broken shale of the Paynes Shale and Sandstone Member to a height of 46 ft. at this site (Photo 40). The cut slope also contains some terrace deposits of slightly cemented gravel (Photo 41).

Sta. 239+00 to 245+00. Photo taken 4 years
later of same cut slopes. Note gravels on
left performed better than the sheared shale
on the right.

The slope on the left has failed and will probably continue to flatten to an approximate 1 1/2:1. There is continual raveling at the bottom and the fence will have to be moved back at the top. A 1 1/2:1 slope would have been a more suitable design on the left. However, the 17 ft. high 3/4:1 stepped slope on the right is performing well.

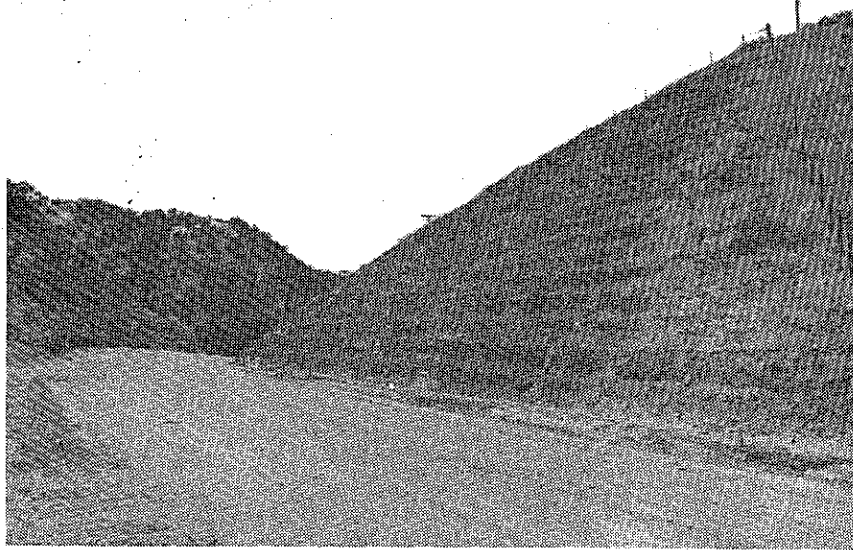
Photo 42

Sta. 262+00 to 267+00. Looking down station
at stepped slope.

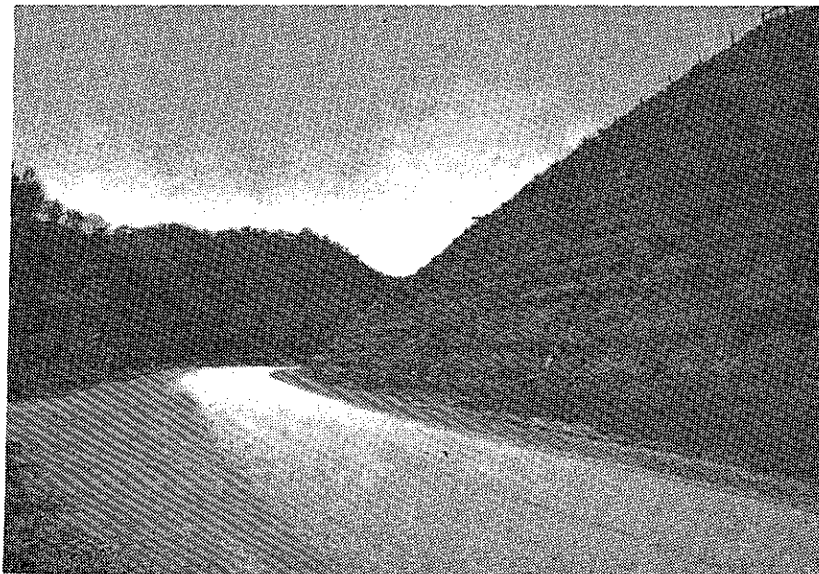
Photo 43

Sta. 262+00 to 267+00. Same view 4 years
later. Very little change.

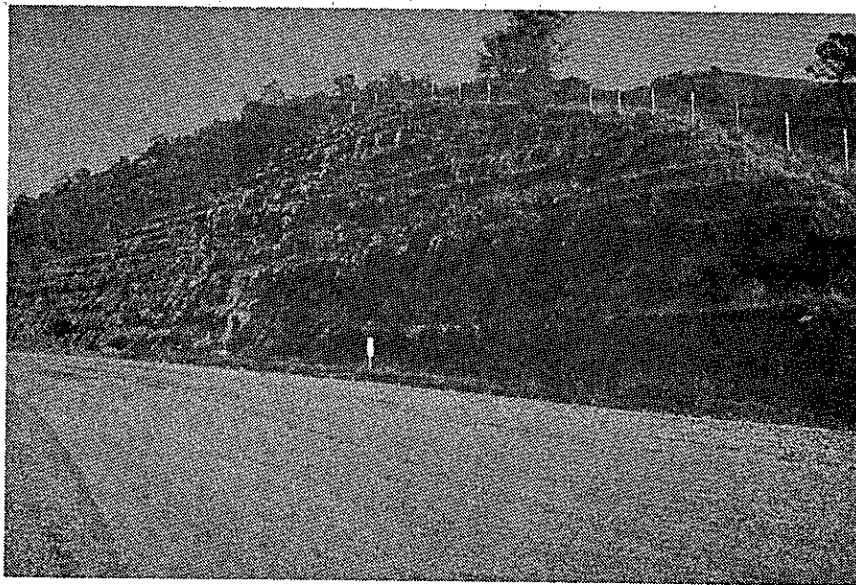
Photo 44

Sta. 262+00 to 267+00 Rt. Stepped cut slope.
12/9/76

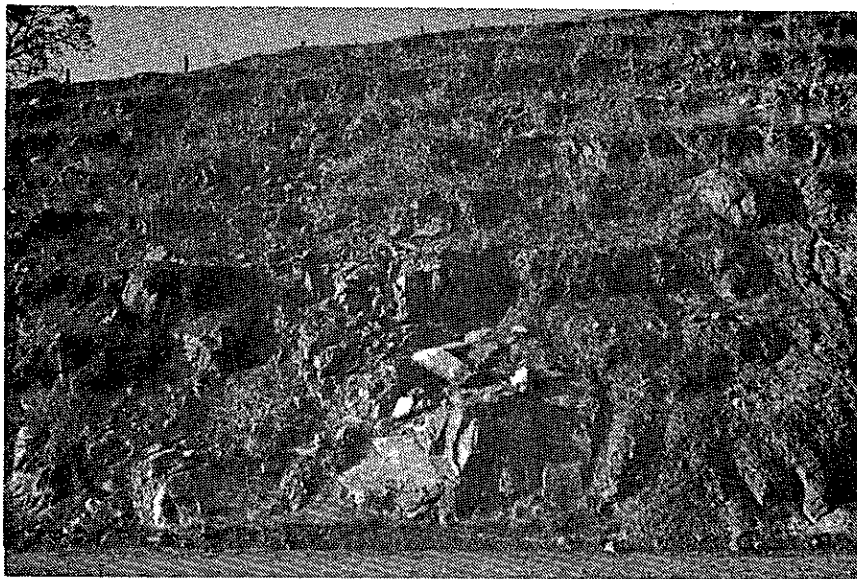
Photo 45

Overall the slope design both left and right is performing well. Where hard sandstone was encountered, (see Photo 45), the steps are broken and ragged. The steps were constructed with a 4 ft. riser and a 3 ft. tread. Steps with smaller dimensions would have been appropriate for this material.

Sta. 265+00 Rt. Close-up of stepped slope.
12/9/76

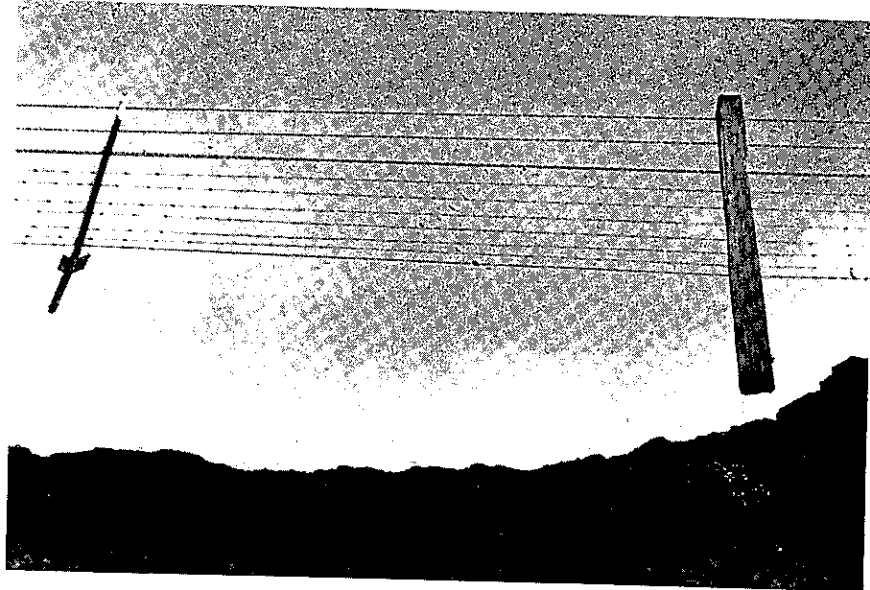
Photo 46

Sta. 65+75 Lt. Fence posts suspended in air
by small slope failure.
12/12/77

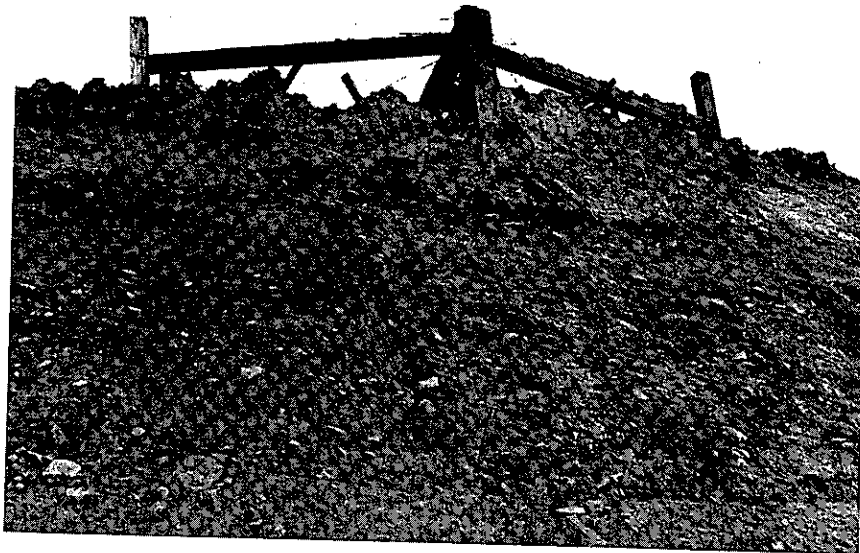
Photo 47

Sta. 66+ Lt. Corner post exposed by slope
excavation.
12/12/77
